INVENTORY FORM FOR STATE HISTORIC SITES SURVEY

Walker-Wagner House

Kent Island Estates vicinity, 101 Somerset Road

QA-274

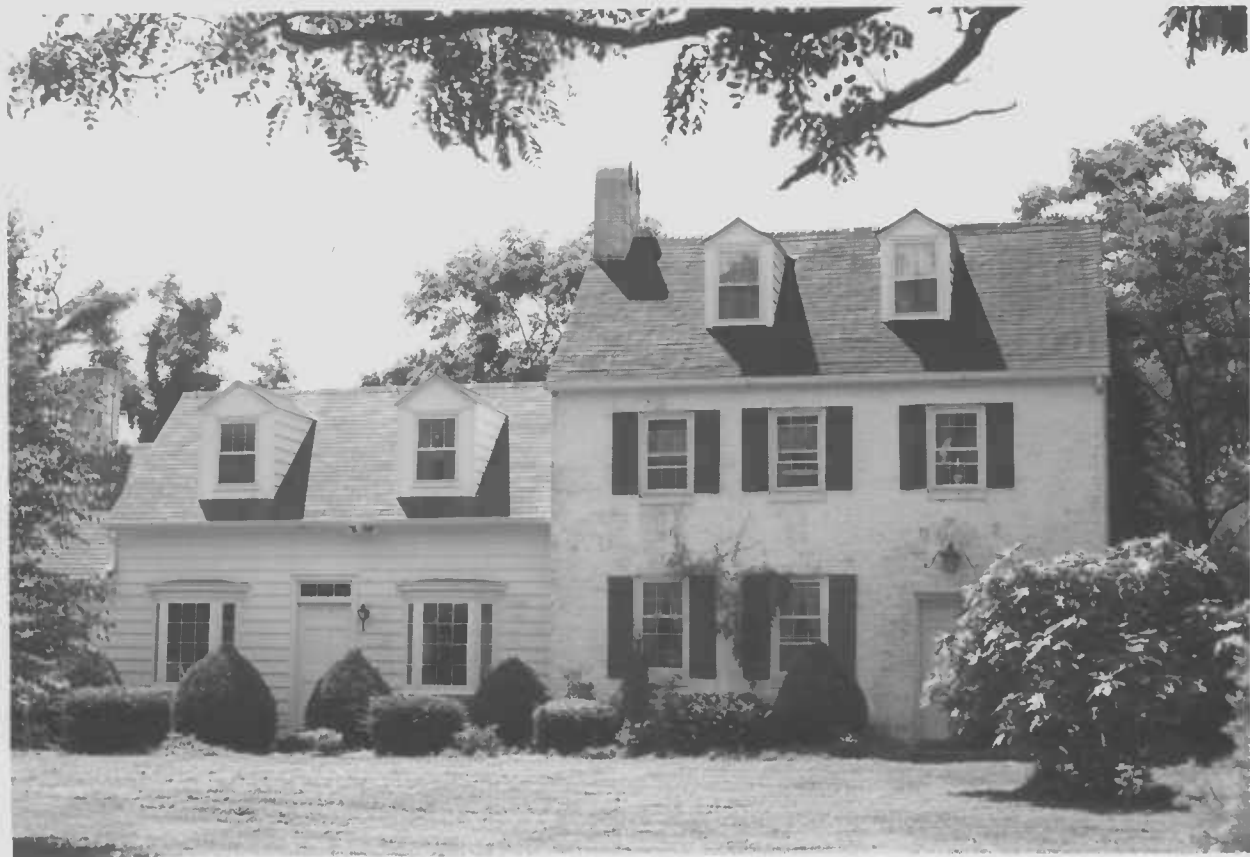
QA-274

The front facade of the main house faces east toward Eastern Bay. The door is located in the north bay, with two 6/9 windows to the south, three 6/6 windows ranged across the second story and two 6/6 pitched roof dormer windows on the third story. The brickwork is laid in five- and six-course common bond with a two-course corbeled cornice. The first and second floor openings have splayed jack arch lintels. The roof is covered with asphalt shingles.

East facade

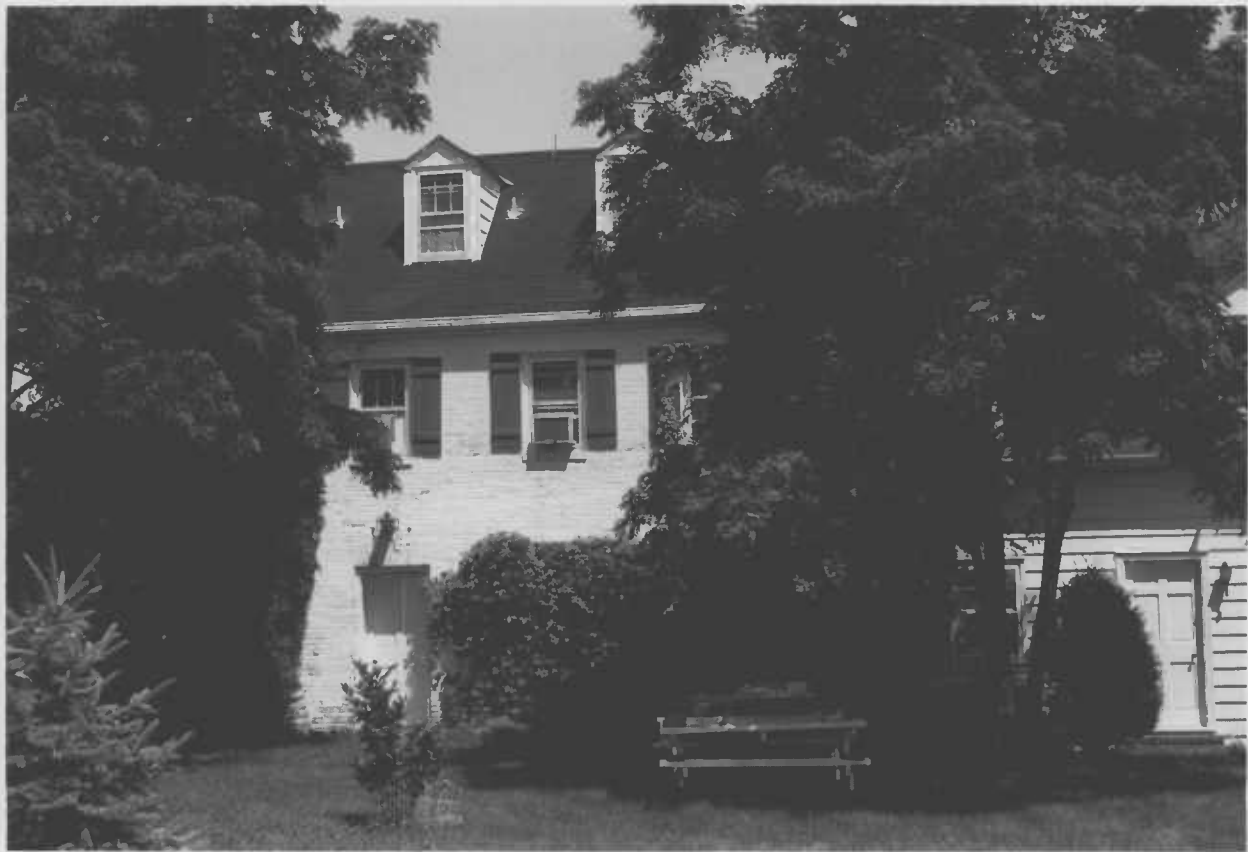
QA-274

The west facade now serves as the rear facade, but in the 19th century may have been considered the front facade, as it faces the original driveway leading in from Route 8. The placement of the interior stair reinforces this possibility. The door is located in the north bay, with two 6/9 windows to the south, three 6/6 windows on the second floor and two 6/6 pitched roof dormers on the third story. The brickwork is random bond with a corbeled cornice and splayed jack arch lintels.

Walker-Wagner House
Romanceke vicinity
Orlando Ridout V 1981
Rear facade from west
